NASA TM X-64754

VAMISTOR RESISTOR INVESTIGATION

Quality and Reliability Assurance Laboratory

May 1, 1973

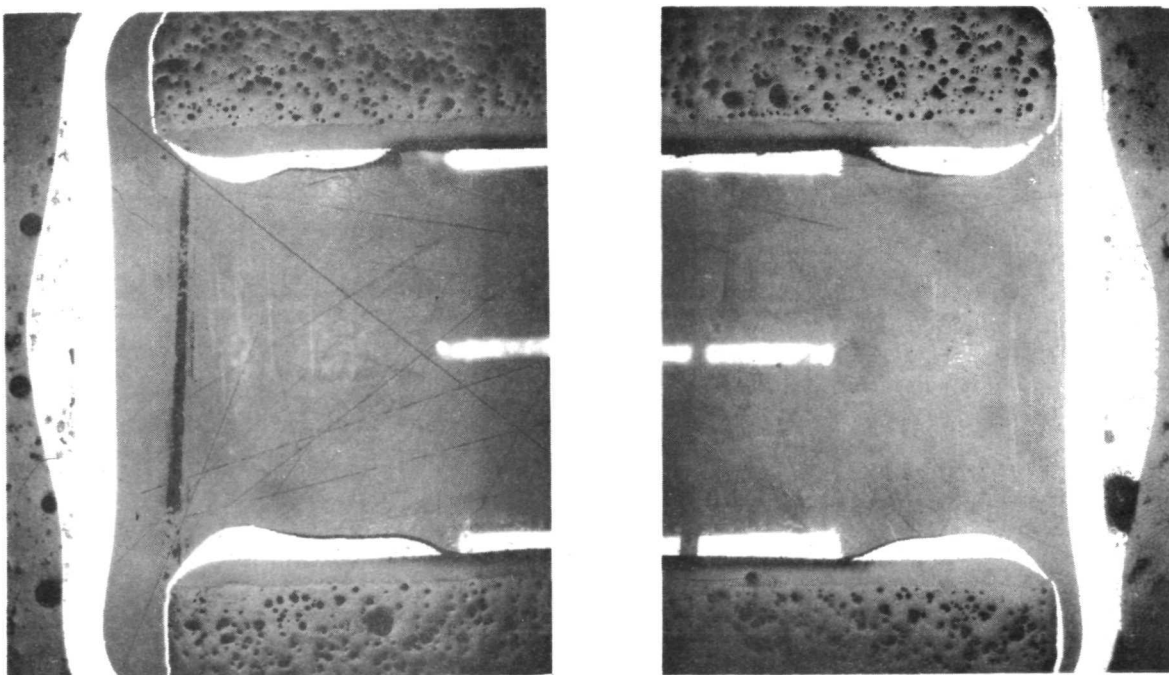
Photo 2: 35X Bad Resistor S/N 135

NOTE: Shows condition of silver coating similar to Photo 1.

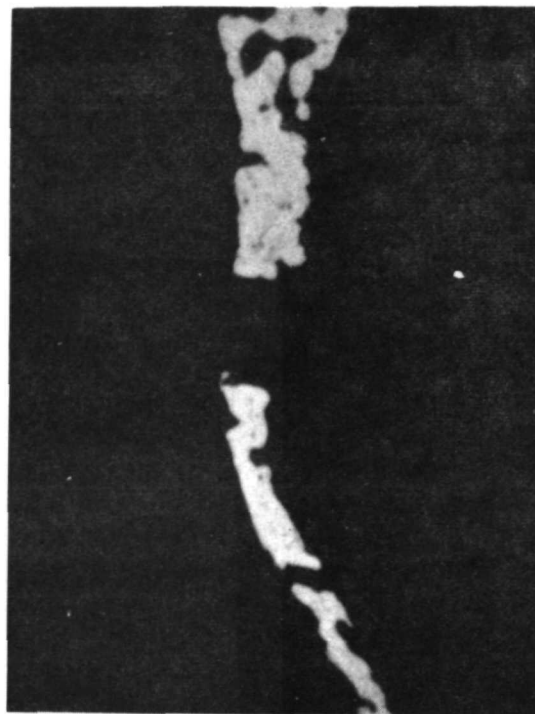
Photo 2: 1000X

NOTE: Illustrates uneven thickness and voided condition of silver coat.

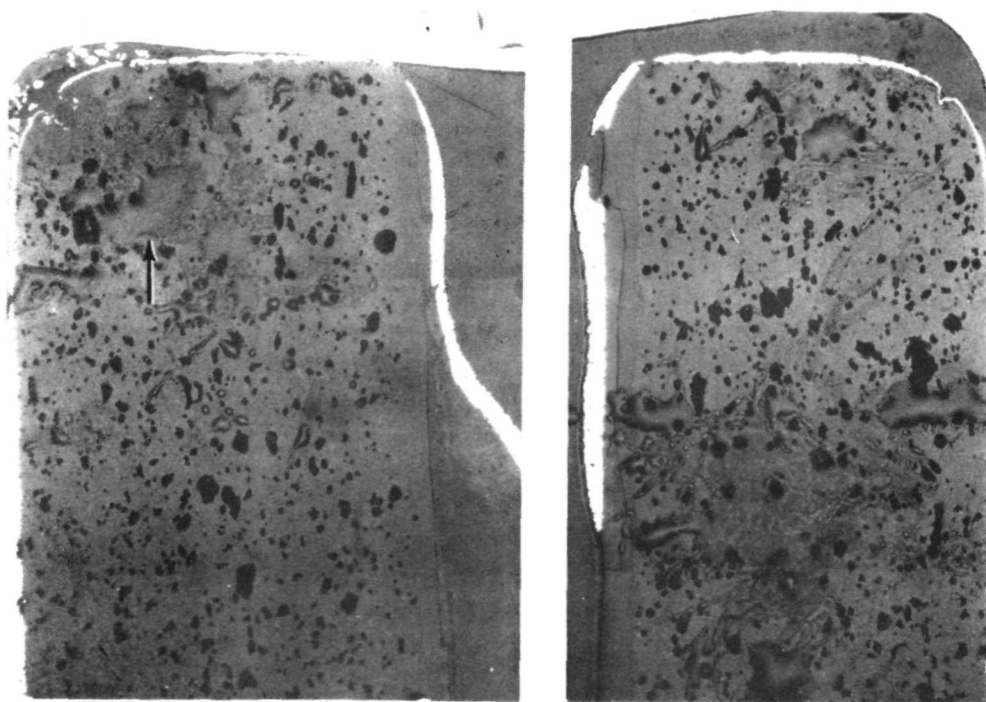
Photo 4: 50X Endcap and Silver over Ceramic Tube Ends

NOTE: Smooth appearing areas on ceramic is retained moisture (typified by arrow). The ceramic at one end of resistor retained more moisture than normal after polishing and had gross voids in silver coating.

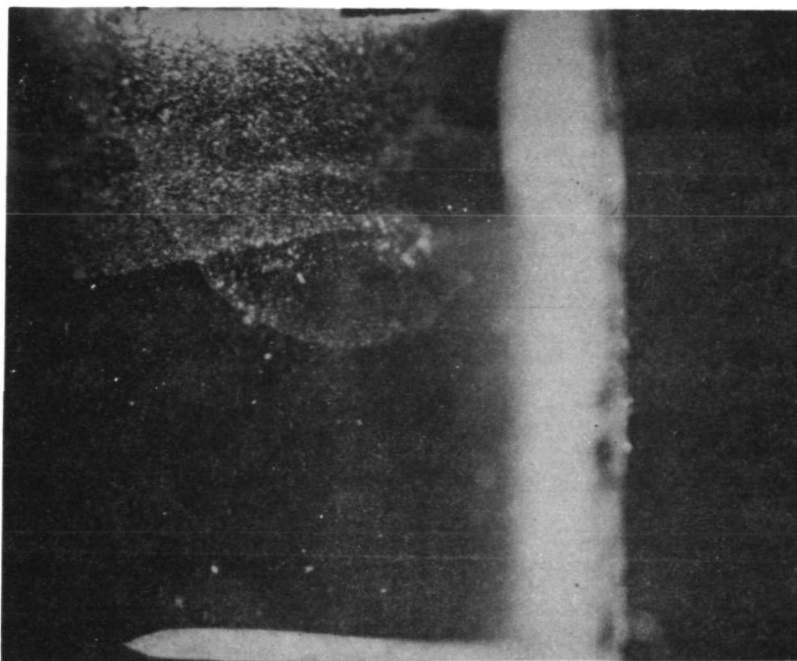
Photo 1: 40X Shows internal residue on metallization.

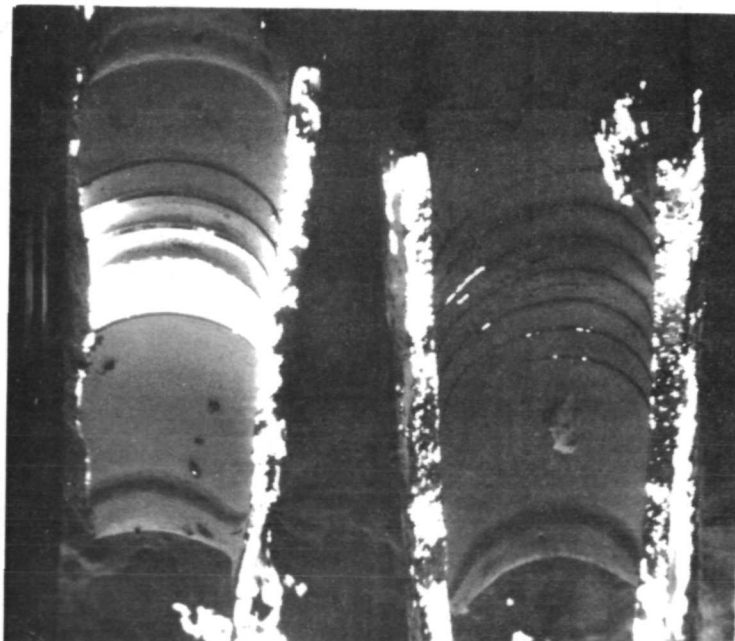
Photo 4: 30KV Note irregularities in resistive material.
Compare with figure 18 photo 3.

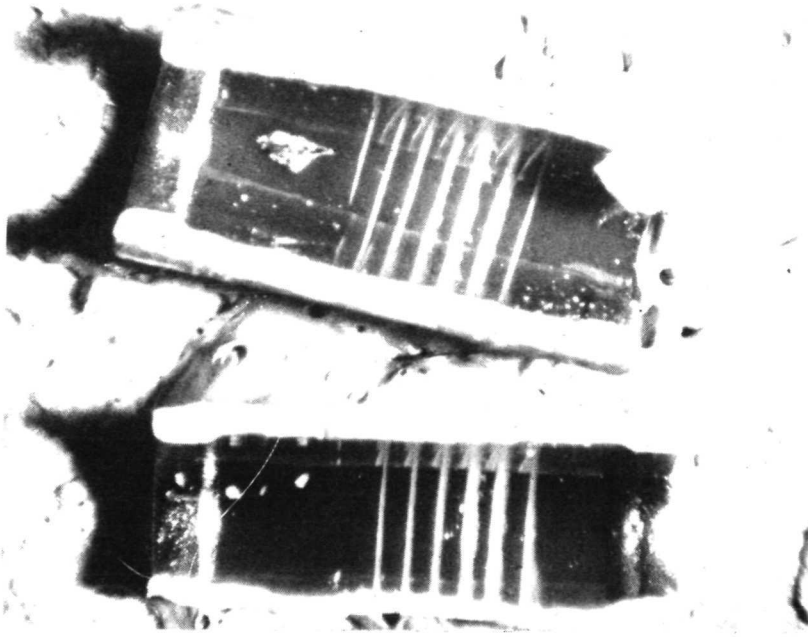
Photo 5: 25X the irregularities in the helix of this photo corresponds to those shown in Photo 4. Also the resistive material between spirals is missing.
